CASE STUDY **FAN FAULT DETECTION** **IN STEEL PLANT**

April 17, 2025

Bottom Seal Gas (BSG) Dedusting system

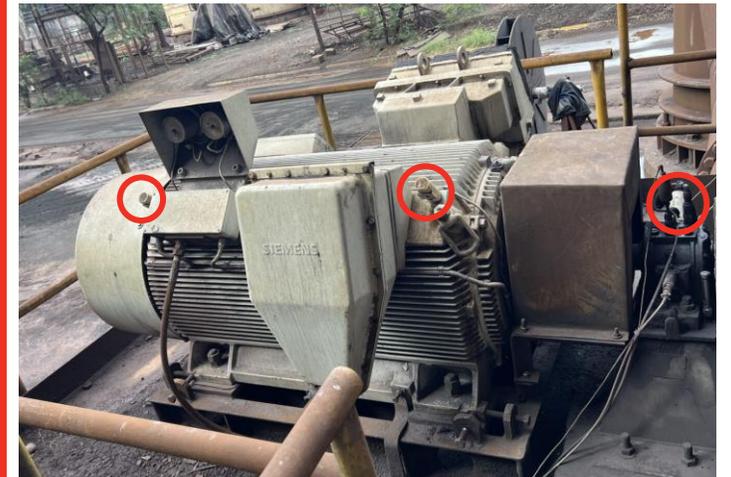
Honeywell Versatilis Transmitter installed on BSG motor & Fan Coupling End (Red circled)

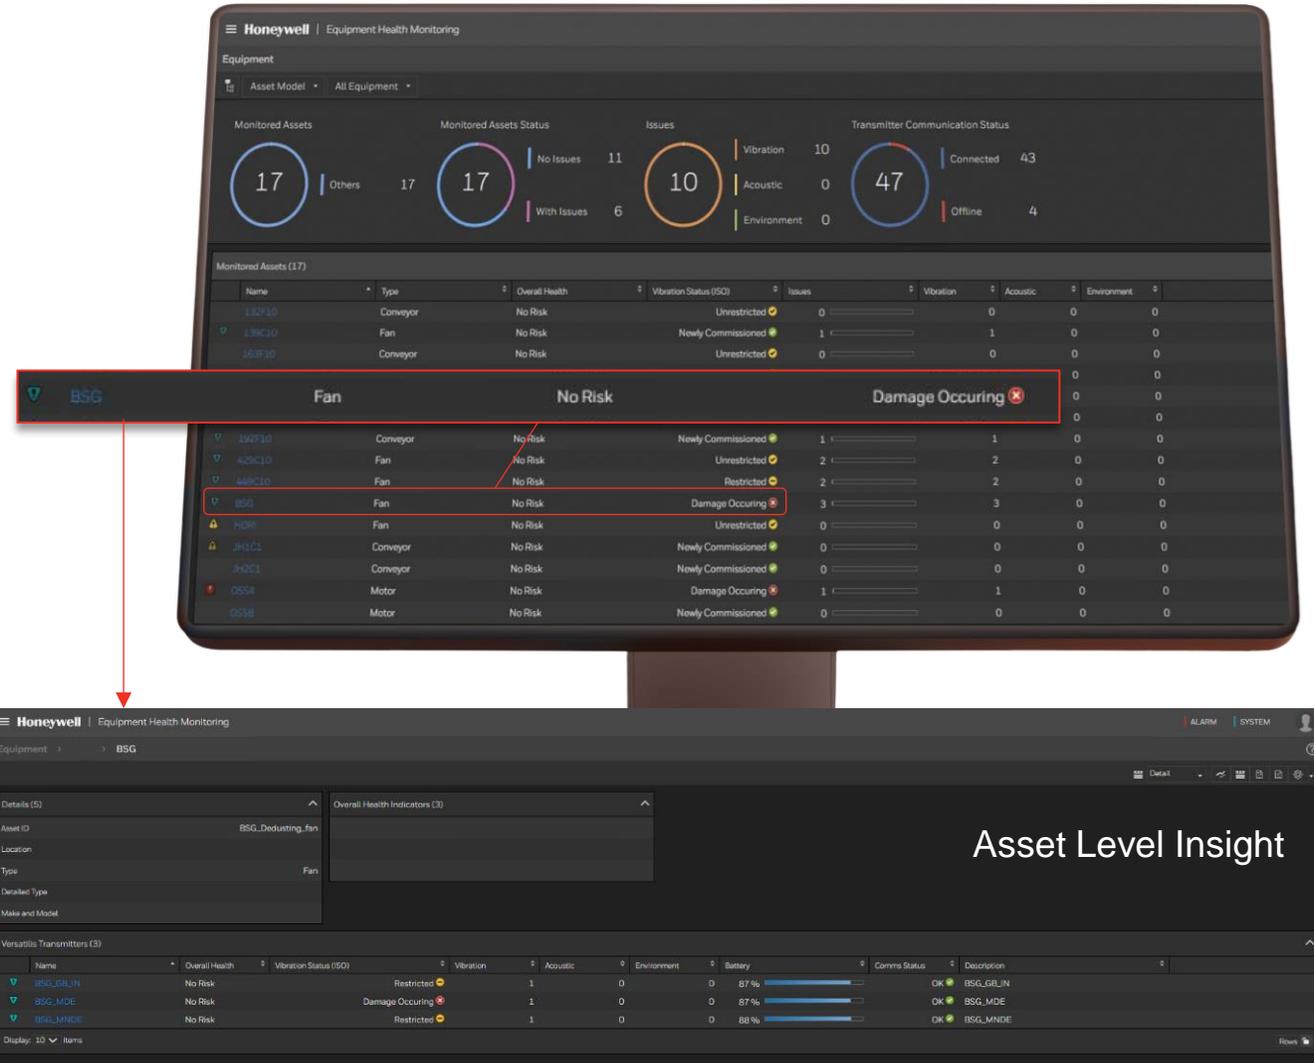
- Customer accessed Experion EHM (on-premise) dashboard which provides site level asset health status.
- ISO 10816-3 standard was used to monitor all 17 machines.
- One of the deoxidizing fans got the ISO Vibration Status to “Damage Occurring” Mode as highlighted in the figure.
- Customer was alerted about the rise in trend in all 3 sensor location.

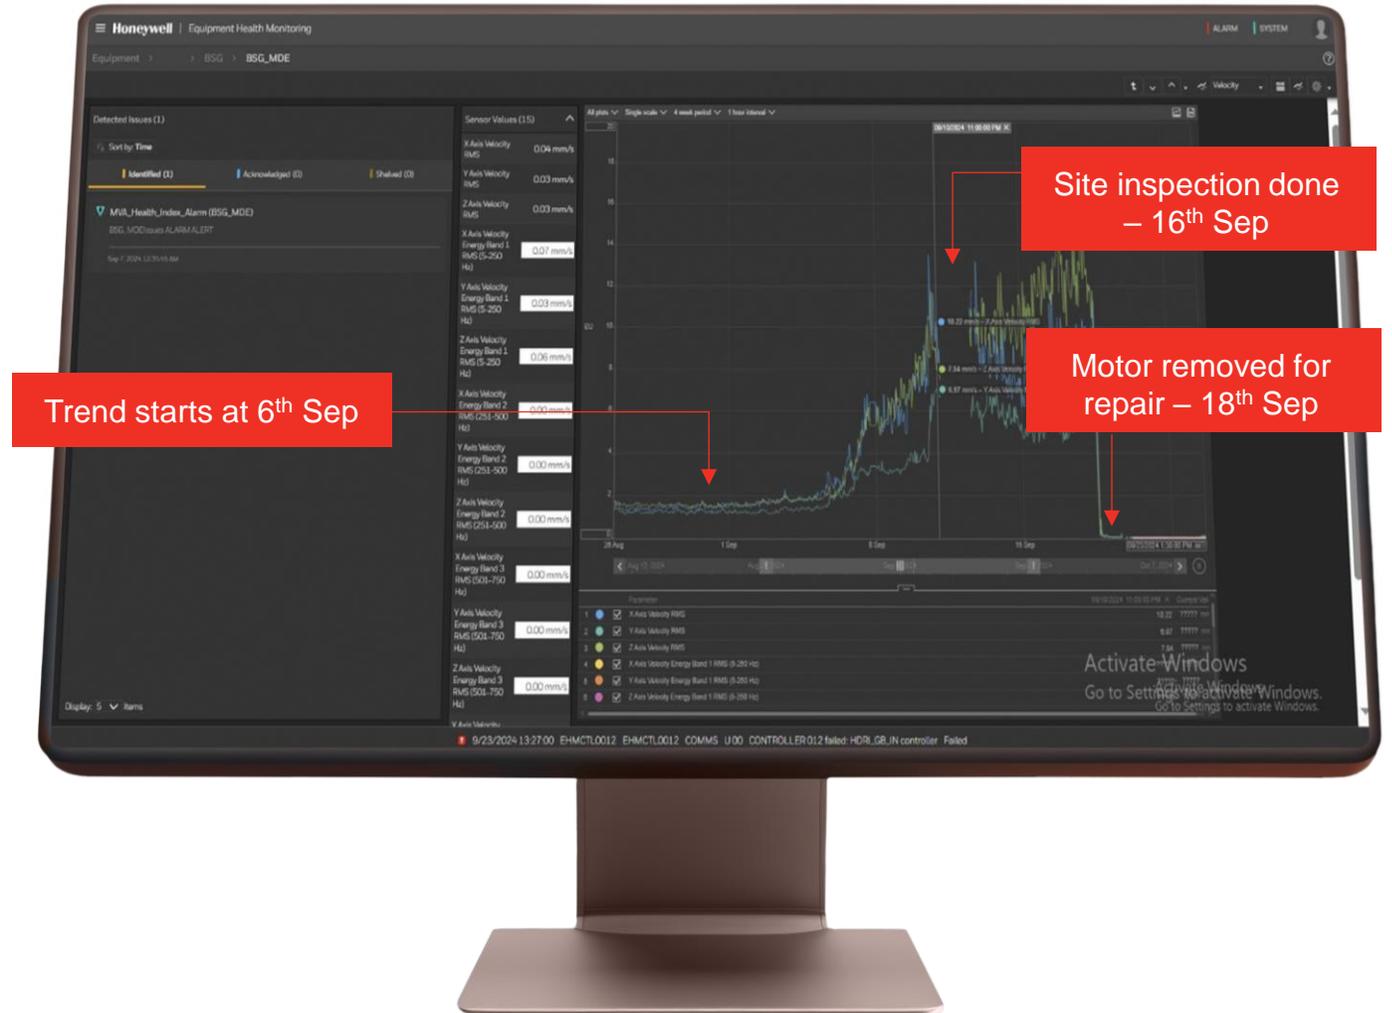
FAN VIBRATION ANALYSIS: MOTOR DRIVE END

- Motor Drive End transmitter showed higher vibration level as compared to ISO 10816-3.
- Velocity level increased from 2 mm/s to 16 mm/s within 10 days of alert.
- The alert helped customer plan the maintenance work on motor by early warning and significant cost saving by avoiding secondary damage.
- After replacement, the velocity readings are below 1 mm/s.

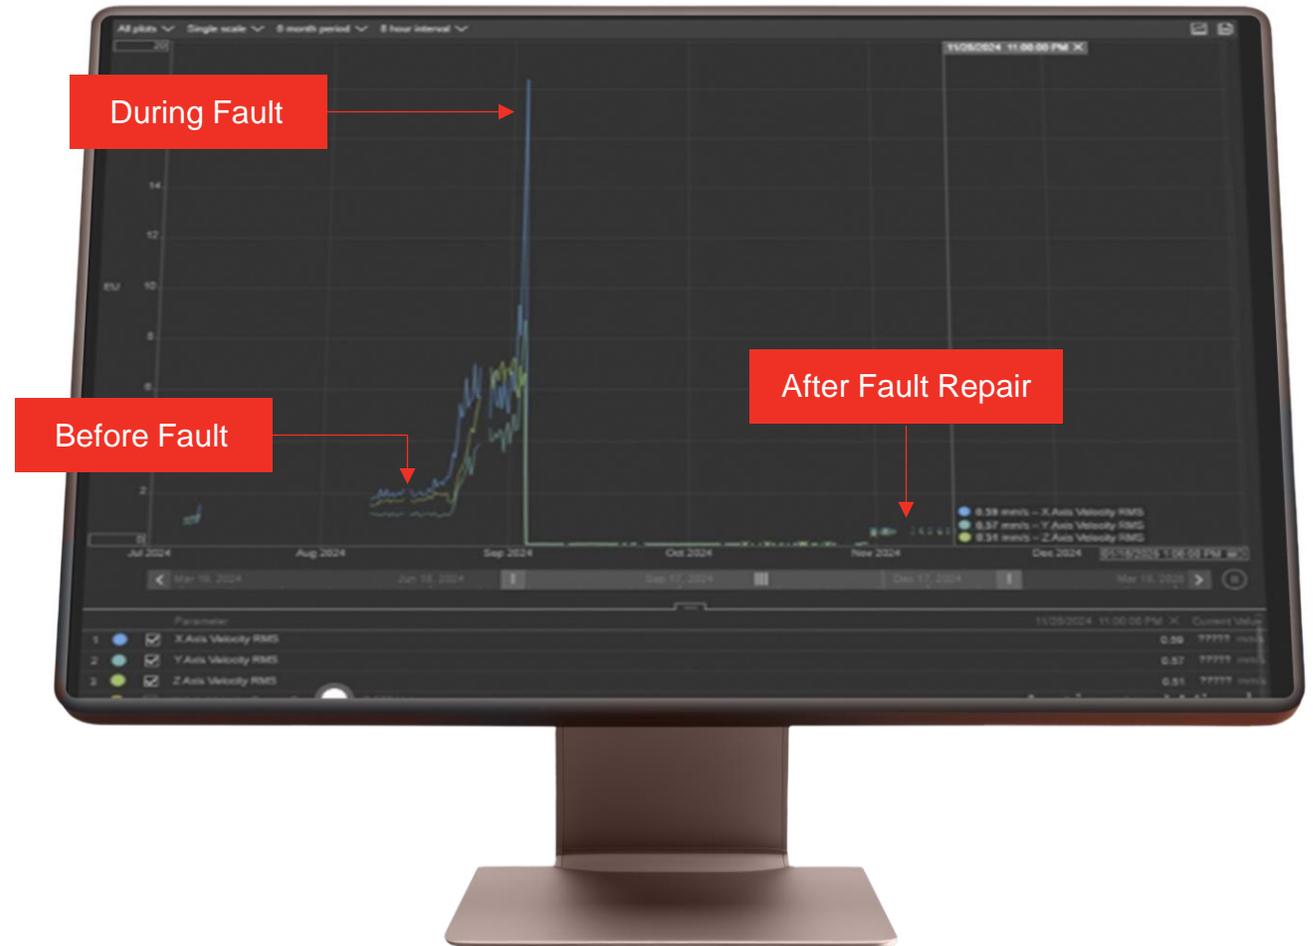
FAN VIBRATION ANALYSIS: MOTOR NON DRIVE END

- Motor Non-Drive End transmitter showed higher vibration level as compared to ISO 10816-3.
- Velocity level increased from 2 mm/s (Before Fault) to 18 mm/s (During Fault) within 10 days of alert.
- After motor replacement, the velocity readings are below 1 mm/s.

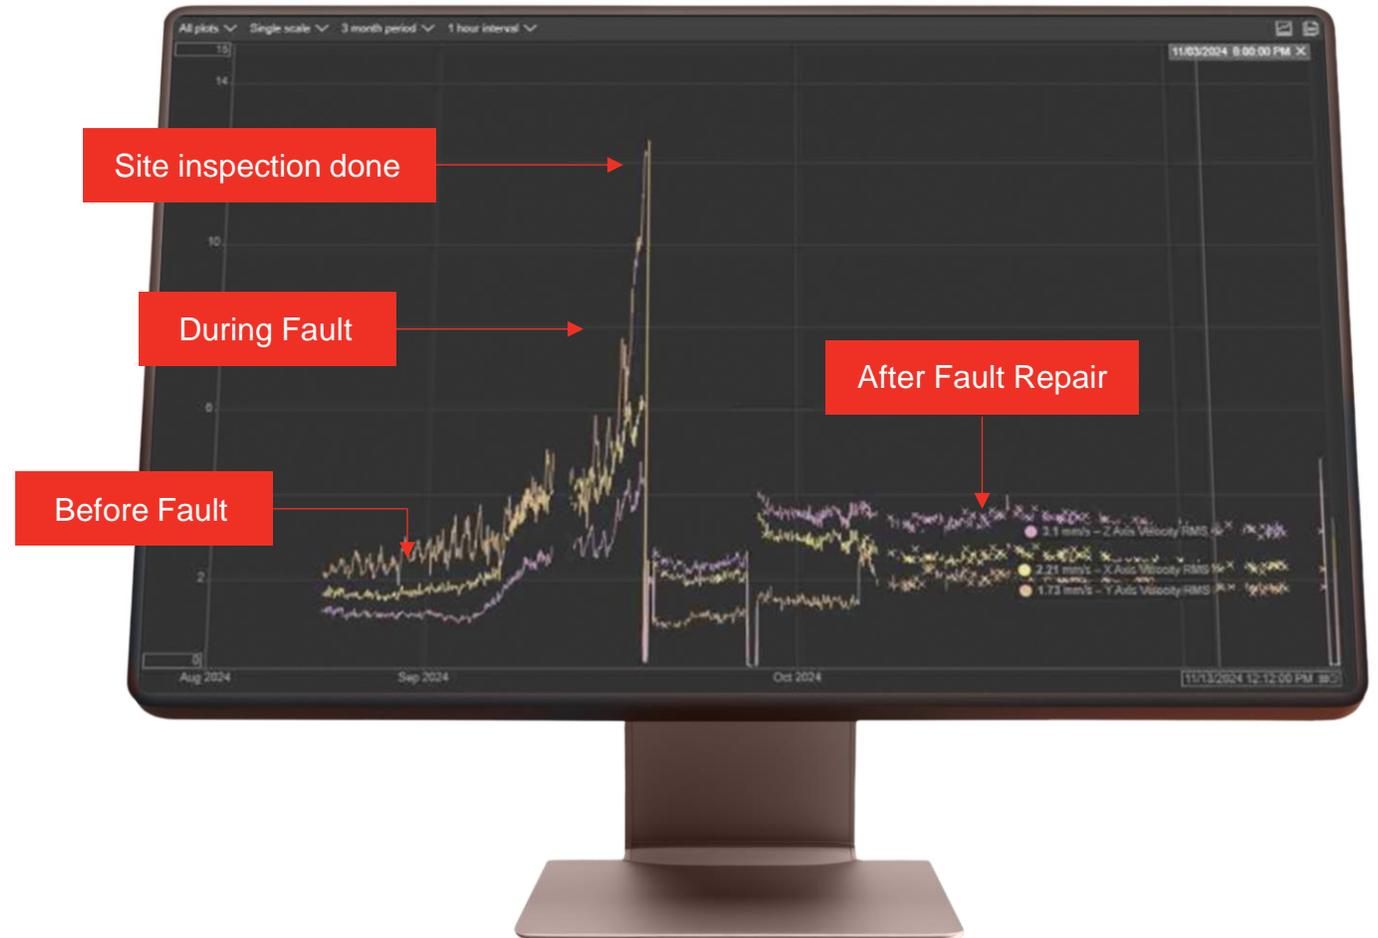
FAN VIBRATION ANALYSIS: FAN COUPLING INPUT

- Fan coupling end transmitter showed higher vibration level as compared to ISO 10816-3.
- Velocity level increased from 3 mm/s (Before Fault) to 12.2 mm/s (During Inspection) within 10 days of alert.
- After motor replacement, the velocity readings are around 3 mm/s.

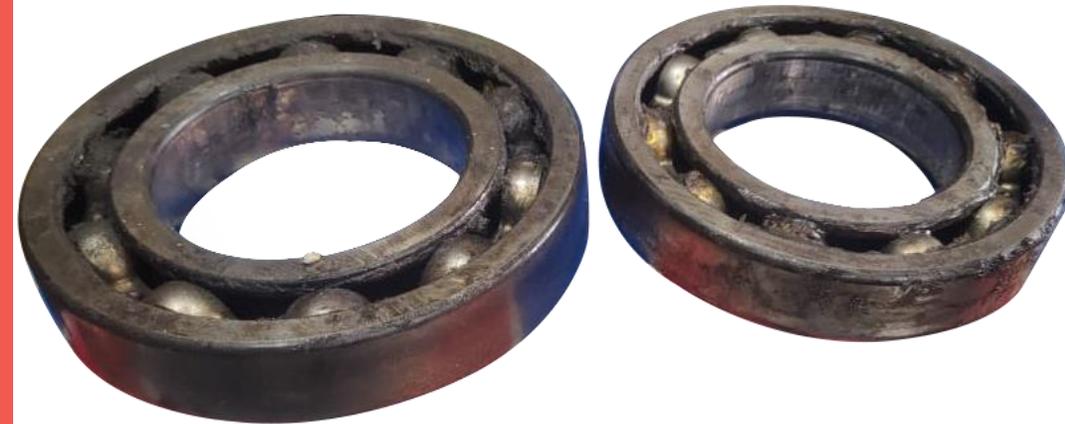
- Found 29.1X order in the vibration spectrum in the horizontal direction at both Motor drive end & non drive end
- Found 12.4X order in vertical direction at Motor end
- G's value at Motor Drive end & non drive end is very high

DAMAGED BEARING OF MOTOR FROM INSPECTION

- Check the condition of the bearings of the Motor Drive End & Non-Drive End
