# White Paper

# Structured Approach to Shift Handover Improves Situation Awareness

Brian Thompson, Engen Petroleum, Ltd., and Tom Plocher, Honeywell ACS Laboratories

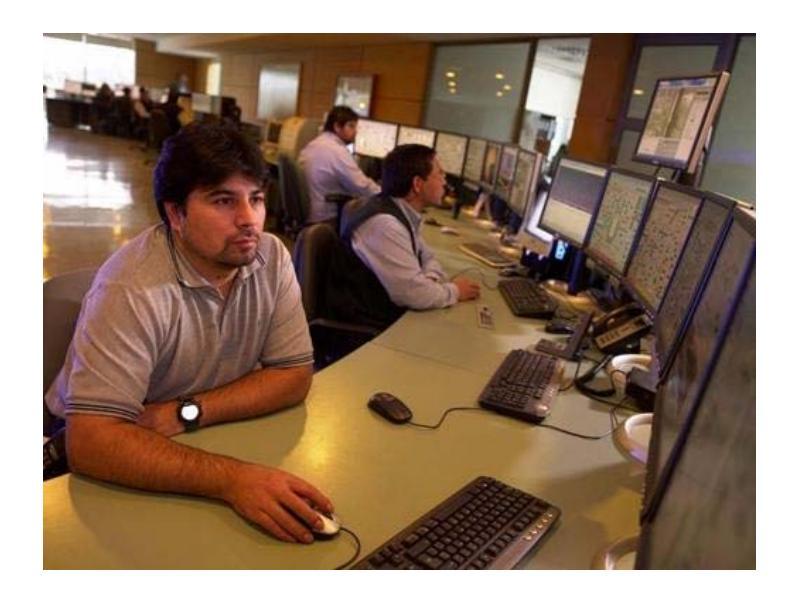
Figure 1. Approximately 80% of industrial operations lack a structured approach to shift handovers.

Approximately 80% of industrial operations lack a structured approach to shift handovers. Numerous disasters have illustrated the potential consequences of poor shift handovers. A lack of structure in shift handovers increases the likelihood that critical information will be missed and misunderstandings will occur. However, the value of a structured approach has never been demonstrated experimentally (See Fig. 1).

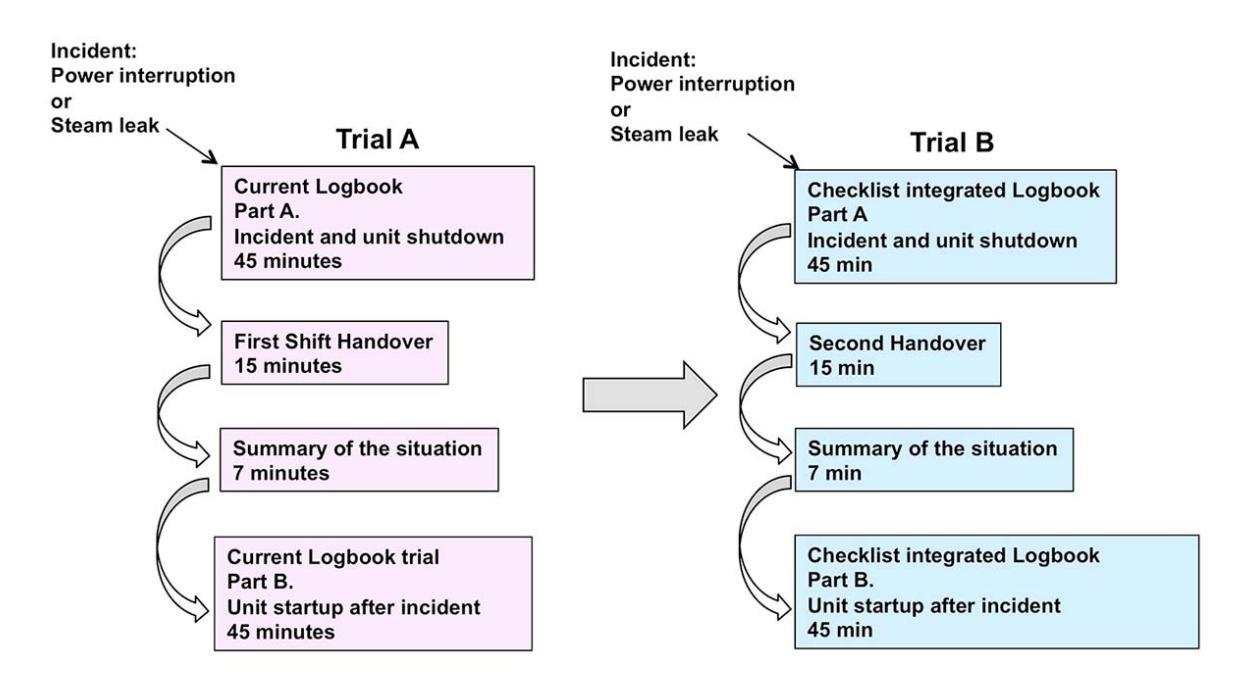
Figure 5. Experiment protocol.

Experienced operators were put through two simulated emergency scenarios: a steam pipe rupture and

a power failure that caused pumps to fail. The scenarios were designed to force a significant amount of interaction between the console operator, field operators, supervisor and other plant operators. The operators had to recognize the abnormal situation, shut down affected unit, and communicate the status of situation to second shift operator during shift handover. The second shift personnel's task was to understand the situation and safely bring the unit back into stable operation.

Events of each emergency scenario were designed to include at least one instance of each information category in the checklist-integrated logbook, thus generating a significant number of key items of information affecting unit startup during the second shift. Additional events, not related specifically to the checklist, were included in the scenarios to serve as distractions (See Fig. 5).

- 20 console operators with varying experience
- 1 to 25 years behind DCS (median = 6.5)
- 6 to 35 years of operations experience (median = 20.35)
- 27 to 62 years of age (median = 39.5)
- 20 operators → 10 pairs of Operator 1 & Operator 2
- Trial A: Operator 1 hands off to Operator 2
- Trial B: Operator 2 hands off to Operator 1
- New integrated logbook introduced during every second trial of the day
- Two scenarios (power failure & steam leak) alternated between Trial A & B

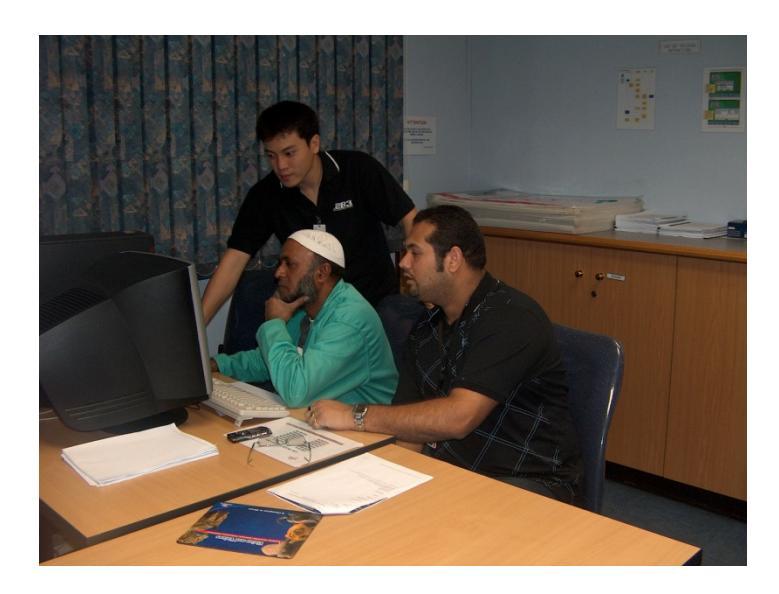
Figure 6. Engen's experiment showed the benefits to situation awareness that derive from a more structured shift handover approach.

Engen's experiment showed the benefits to situation awareness that derive from a more structured shift handover approach. The checklist-integrated logbook generated higher-quality log entries compared to model logbook entries generated by Engen operations experts (+18.6%). Second shift operators were able to provide a more accurate and comprehensive account of the unit situation (+9%). Operators were also better at answering questions without the need to consult supervisors and team members (+8%). In addition, structured handovers took only a minute or so longer than those conducted in a less structured way (+16%) (See Fig. 6).

The Durban study found structured shift handovers do not necessarily require "more time." Structured handovers took only slightly longer on average than a less structured approach, and there were relatively low time costs for improved handover quality. The experiment did show that filling out a checklist-integrated logbook was more "time-consuming." In the real world, however, logs are updated periodically throughout the entire shift.
