MODERNIZING A LUMBER PRODUCTION ENVIRONMENT WITH HONEYWELL SLATE AND THERMAL IQ SOLUTIONS

Application Note

Honeywell and channel partner Martin Control & Equipment Company helps a leading US lumber company upgrade its 30-year-old kiln to satisfy sold-out demand and avoid over \$200K in lost production.

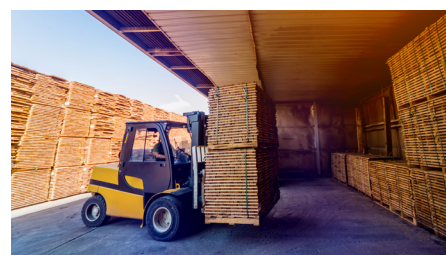
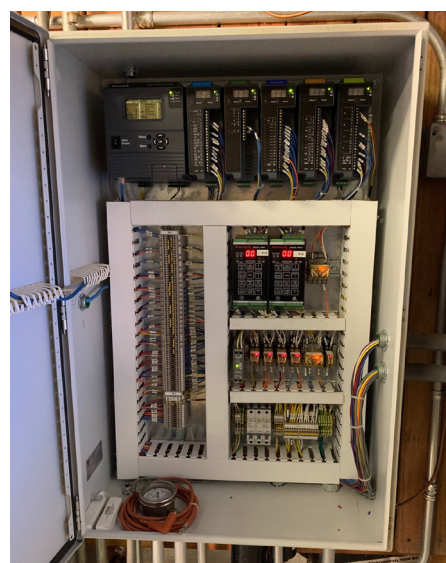
Upgraded kiln cabinet with SLATE combustion controls.

Martin Control's plans included the design and installation of state-of-the-art Honeywell equipment, including SLATE™ burner management and burner control systems. The system

provides intuitive diagnostics via simple, easy-to-understand messages to enable real-time platform monitoring for timely, informed decision-making. The HMI touchscreen provides rich graphical content to highlight the annunciations for alarm detection. The centerpiece of the solution was Honeywell's Thermal IQ™ remote monitoring platform.

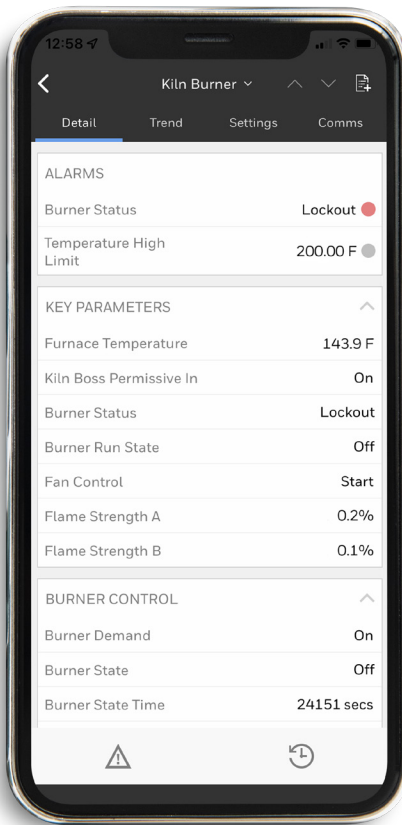
Real-time monitoring and alerts drove visibility to the remote Martin Control team.

The Martin Control & Equipment Company team began to receive Thermal IQ push notifications about the downward trend of the failing scanner as it strayed outside normal limits. They used the Thermal IQ mobile app to look at other thermal processes information in real time such as temperature, burner status, burner run state, fan status, and burner demand without being present at their facility.

Because the Martin Control team knew exactly what the problem was by comparing data in the Thermal IQ historian and remotely logging into SLATE, their service technician brought the correct tools and parts

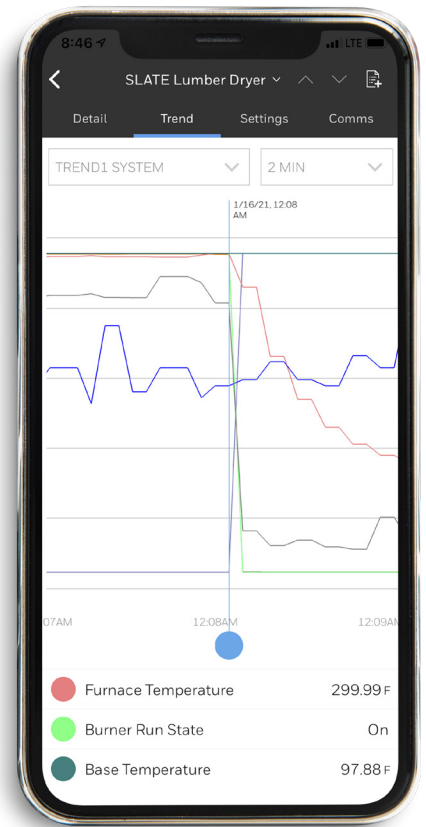
Thermal IQ platform provides real-time information and historical data to support troubleshooting.

The teams were able to compare operating parameters to better understand what was occurring prior to and after the lockout for enhanced troubleshooting.

data intelligence, from notification of system trips or stoppages and the root cause of annunciator failures to data relating to temperature, flame signal, burner status and run rate, fan status, and burner demand.
